**1996 BOARD
OF
EQUALIZATION**

Subject: Professional Engineering Assessment of Contraction Defects in a
Residence

Subject: Estimate of Repairs -- Eck Residence

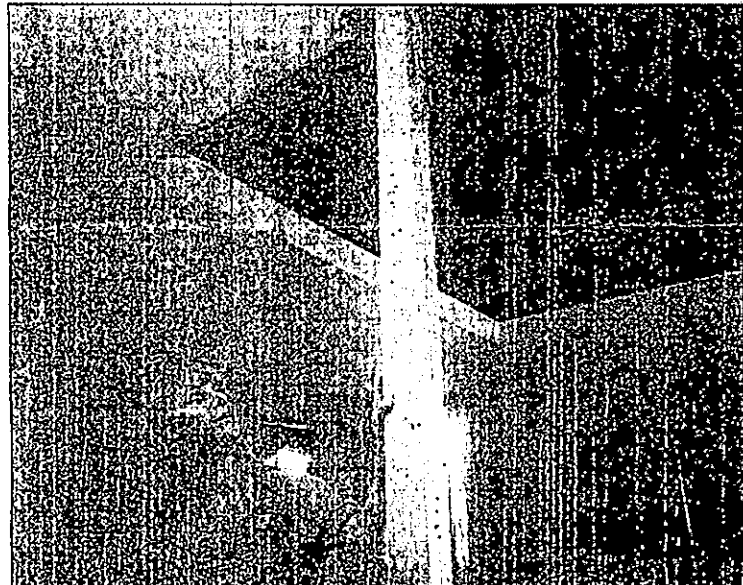
Darlene Eck gazes at a makeshift support beam running through her bedroom. "I feel better when the support beams are up, but they are still not safe," she says. She and her husband, Kenny, bought the house in 1993.

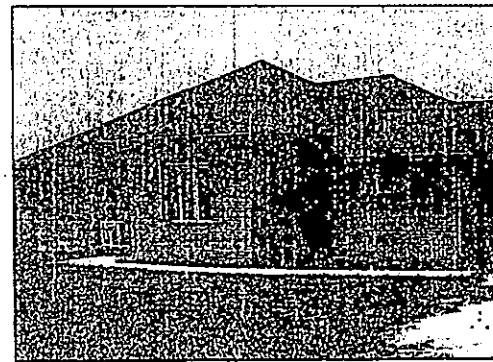
The Eck home looks fine from the exterior. But beneath the backyard are sewage problems — such as the lack of a sewer line. The Ecks have filed lawsuits against the builders of the home and the inspector.

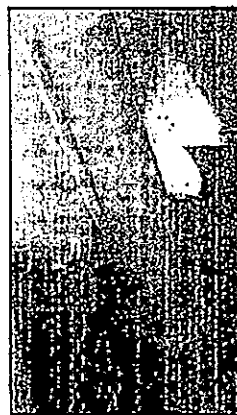
The smell of sewage led the Ecks to rip open a floor in search of broken plumbing. What they found was the broken pipe and a structural support beam that had been hacked to make space for pipes. The result: a greatly weakened support beam.

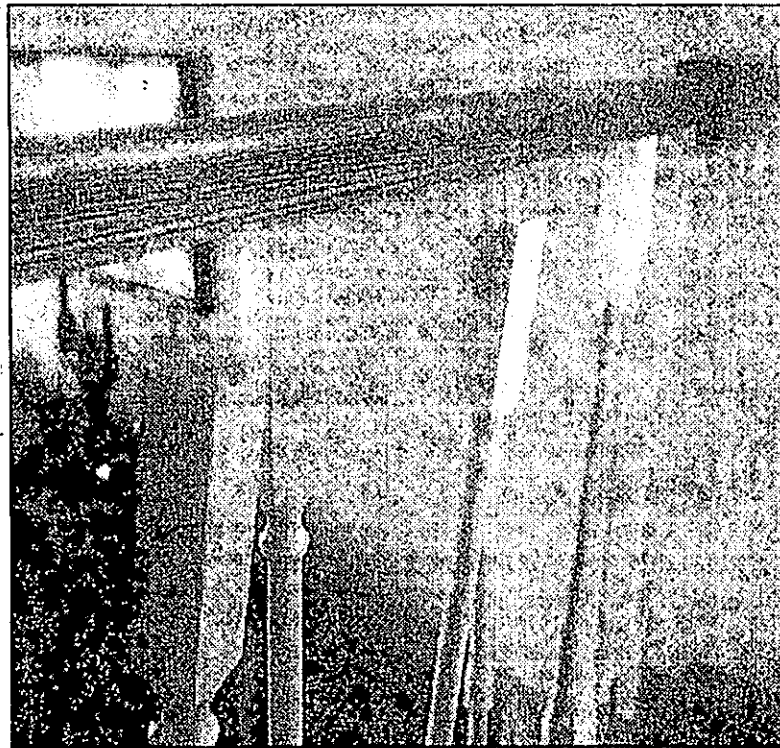
This bannister has all but fallen apart, leaving toddler Austin Eck — or virtually anyone else — in danger, Darlene Eck says. The railing, or what remains of it, is held together with one nail and some glue.

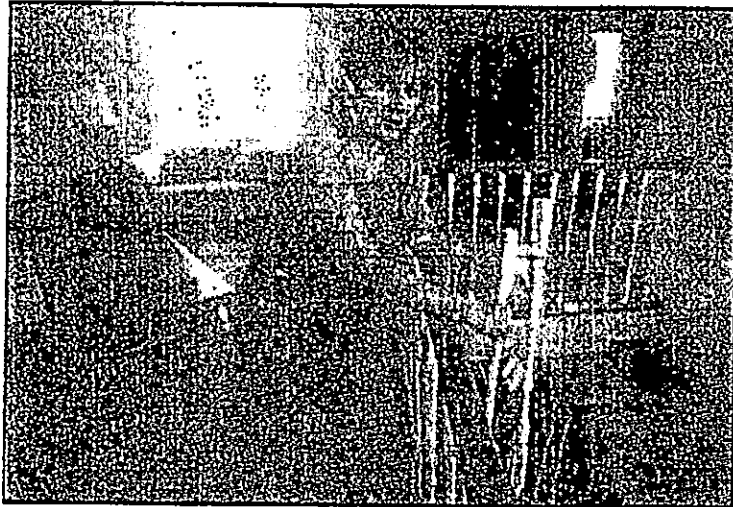
Darlene Eck holds pieces of her broken bannister, which is held together by a nail and a little glue. The Ecks have filed lawsuits against the builders and inspector of their home near Billings.
